INSTALLATION, OPERATION, & MAINTENANCE OF APOLLO BARSTOCK VALVES

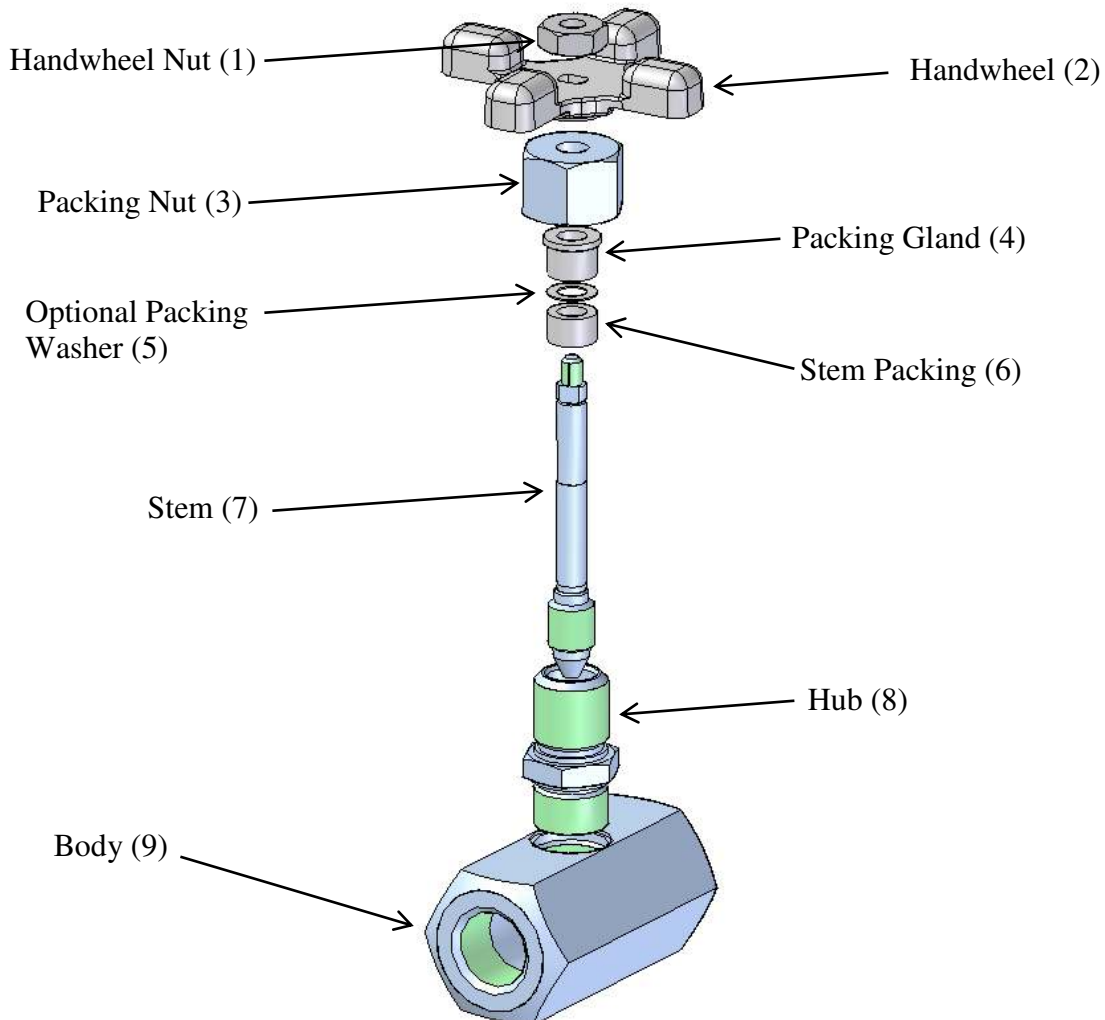
1. Remove the handwheel or handle nut (1), handwheel or handle (2), packing nut (3), and packing gland (4) and packing washer (5), if applicable.
2. Remove the old stem packing (6). Care should be taken not to scratch or damage the stem or stuffing box.
3. Clean and inspect the stem, stuffing box, and gland. Parts should be replaced if any heavy scratches, nicks, or corrosion are found.
4. Install the new stem packing.
5. Replace the packing washer (5), if applicable, the packing gland (4), packing nut (3), handwheel or handle (2), and handwheel or handle nut (1).
6. Tighten the packing nut until the packing is lightly compressed. Cycle the valve several times.
7. If slight stem leakage occurs after the system is pressurized, continue tightening the packing nut in quarter-turn increments until the leakage stops.

The most common area of leakage is around the stem and packing. Adjusting the packing nut can normally stop most leakage issues. If tightening the packing nut does not stop the stem leakage, the stem packing must be replaced.

All Apollo globe valves are equipped with backseats which are 100% tested prior to shipment. However, once the valve is put into service, corrosion and foreign material can affect the sealing integrity of the backseat. Therefore, **REPACKING UNDER PRESSURE CAN BE HAZARDOUS**. For this reason, Aalberts IPS strongly recommends that the system and valve be depressurized before attempting any repair work. After isolating the valve from pressure, the following procedure should be used to repack the valve.
